Damage to Masonry Buildings Caused by the El Salvador Earthquake of January 13, 2001

Koji YOSHIMURA and Masayuki KUROKI
Department of Architectural Engineering, Oita University,
(Received for 10 Sep., 2001)

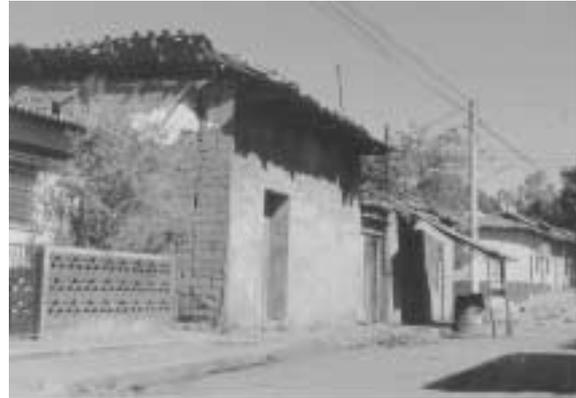
Photo 12. Vertical crack at the corner of an adobe wall in Usulután.

El Salvador was that of adobe construction, in which dried clay-mud brick units only are used to erect most walls, very little wall reinforcement being provided in most of them. Photos 11 through 20 show the typical damage done to this type of construction used in residences, churches, and school buildings. Vertical cracks in wall edges at intersections in the plan were presented in most of the damaged buildings. Photo 21 shows an example of a displaced block of adobe bricks 30 cm x 23 cm x 7 cm.

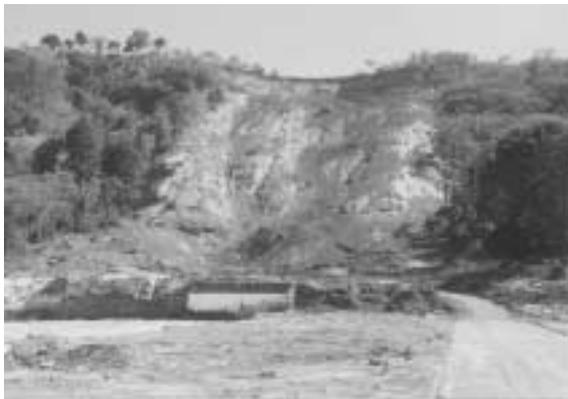
Characteristic of this earthquake was the large number of landslides (see Photos 9 and 10). Of those landslides, the one at Santa Tecla, La Libertad Province was the worst, more than 400 of the 687 people in the Las Colinas district having been killed (Time, 2001).

Photo 9. A landslide in Santa Tecla.

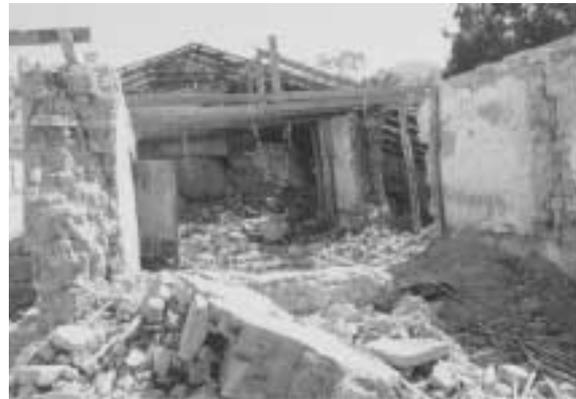
Photo 13. Failure of an adobe house in San Pedro Nonualco.

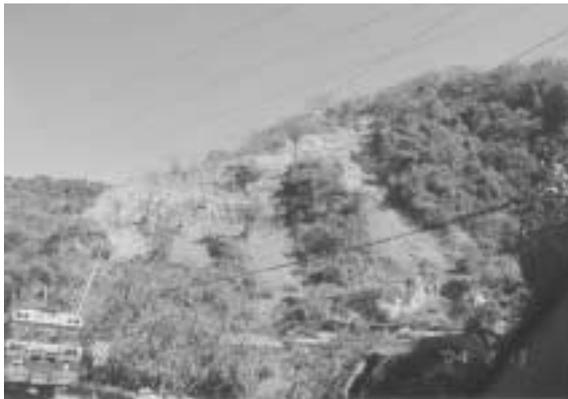
Photo 10. A landslide between San Salvador and Santa Ana.

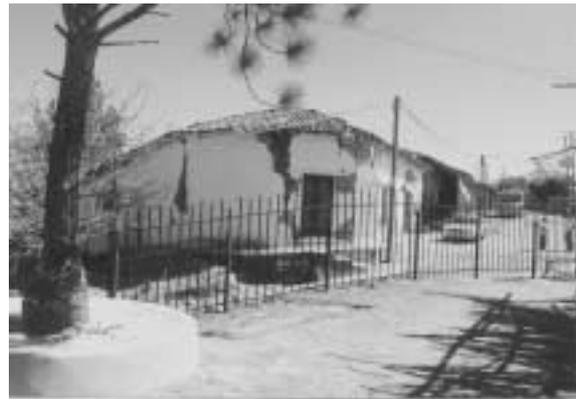
Photo 14. Damage to an adobe house in María Otsuma.

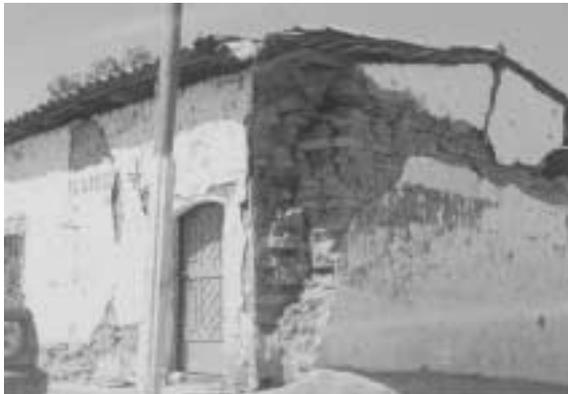
Photo 11. Damage to an adobe house in Santiago Nonualco.

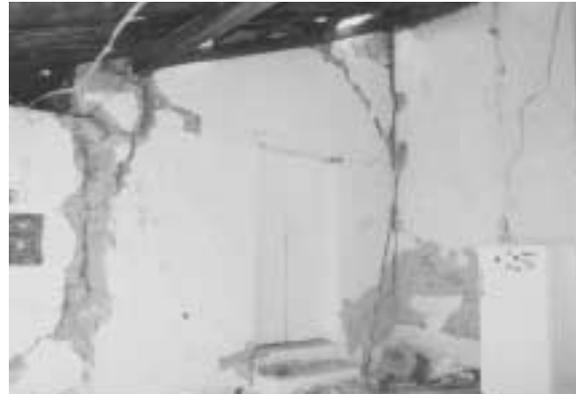
Photo 15. Inside of the house in Photo 14.

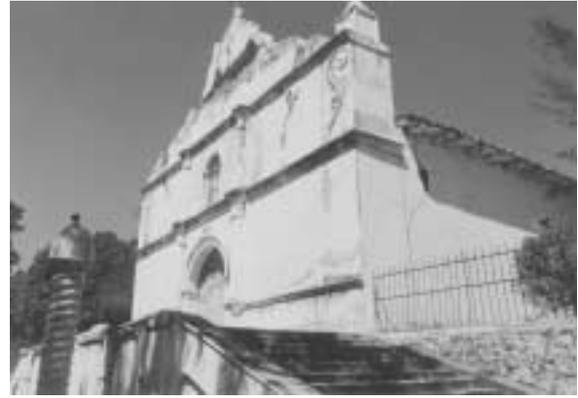
Photo 19. Damage to an adobe church in Zacatecoluca.

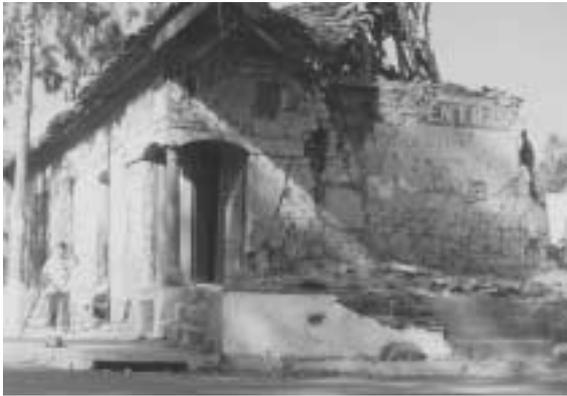
Photo 16. Damage to an adobe store in Santa Tecla.

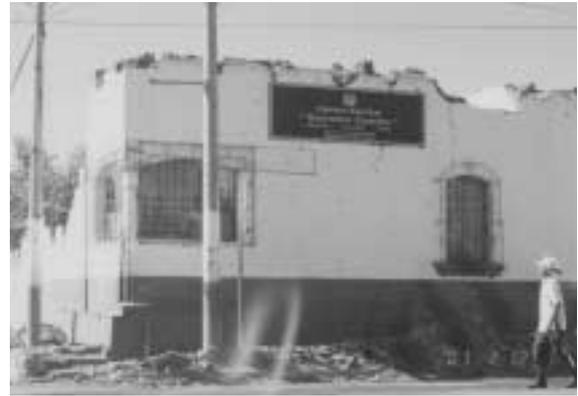
Photo 20. Damage to an adobe school in Usulután.

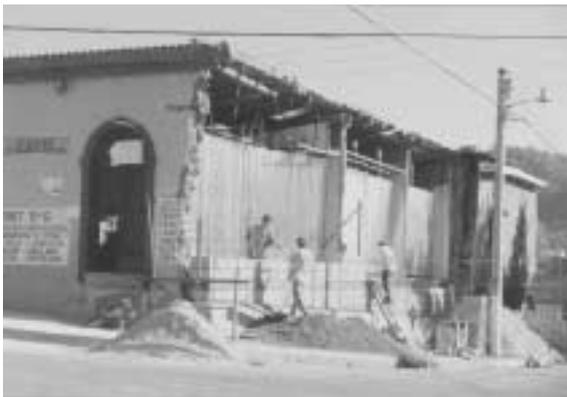
Photo 17. Damage to another adobe store in Santa Tecla.

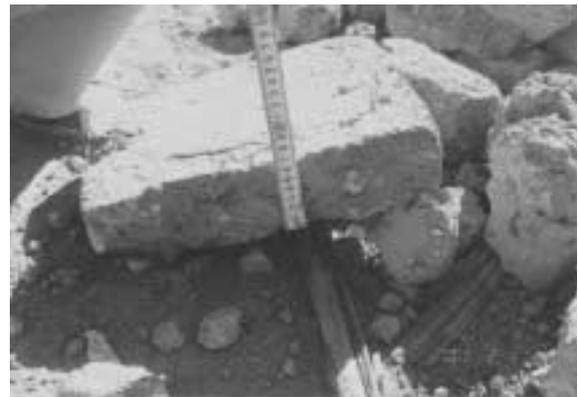
Photo 21. Adobe blocks in San Pedro Nonualco.

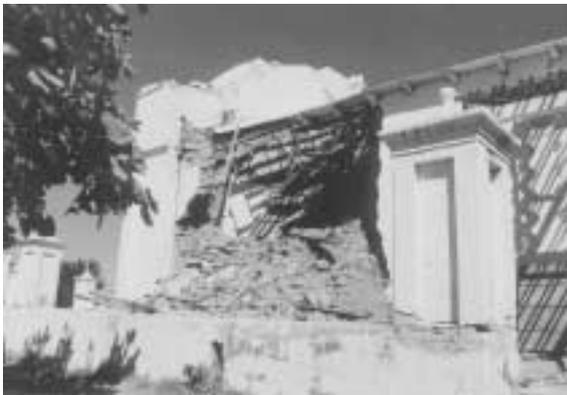
Photo 18. Damage to an adobe church in María Otsuma.

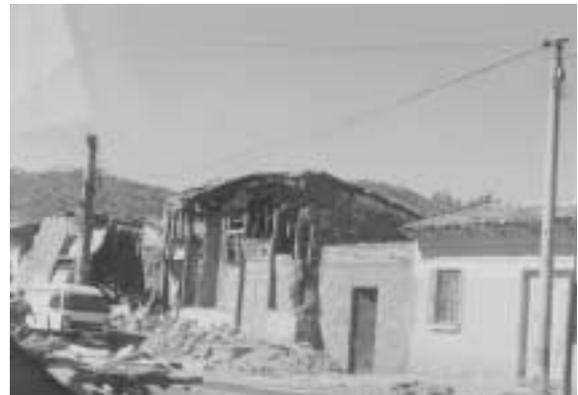
Photo 22. Damage to a mixed timber, bamboo, and mud wall house in Santa Tecla.

traditional wall structure used in house construction in various Latin American countries. The structural (and/or partition) walls are composed of timber frames and/or bamboo (*quincha* in Spanish) with mud or clay filler combined with chopped straws (or whole canes in some cases), and a plaster finish. Photos 22 through 24 show the damage typical to the mixed timber, bamboo, and mud wall type of housing. The crushed mud walls have collapsed causing acute inclination of the building in some cases. A main cause of this type of severe structural damage is the lack of adequate wall strength in both the in- and out-of-plane directions.

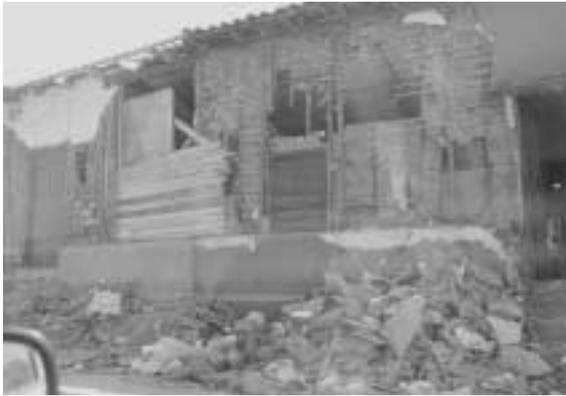
Photo 23. Damage to another mixed timber, bamboo, and mud wall house in Santa Tecla.

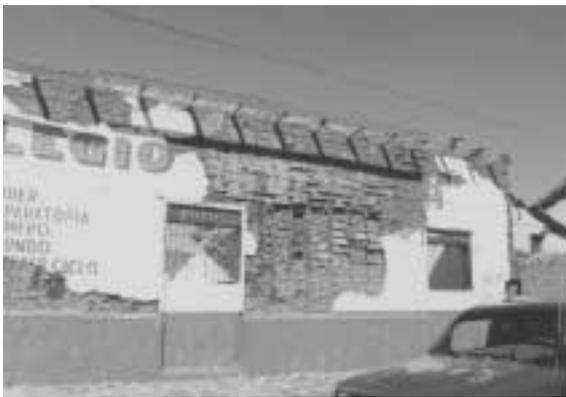
Photo 24. Damage to a mixed timber, bamboo, and mud wall school in Usulután.

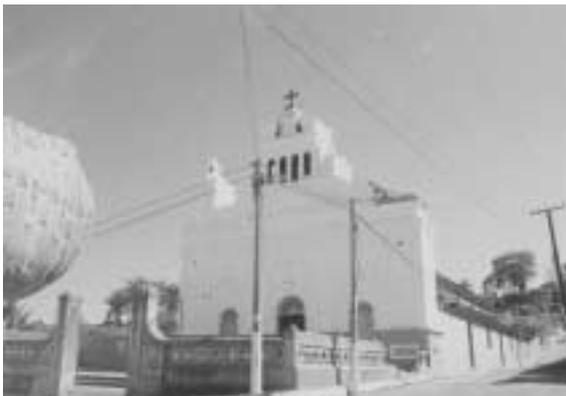
Photo 25. Damage to an un-reinforced masonry wall church in San Pedro Nonualco.

wall structural system widely used throughout the world. Most of the structural and non-structural walls are built of clay bricks and mortar. No wall reinforcement (such as steel reinforcing bars) is provided within the walls in either the horizontal or vertical direction. Because these brown clay bricks usually are fired at a relatively low temperature, excellent mechanical properties such as high compressive strength can not be obtained (Photos 27, 28 and 29). Although no severe structural damage to the many buildings constructed by this structural system was observed, some church buildings showed damage; bell towers and spires cantilevered at the tops of the buildings cracked and totally collapsed.

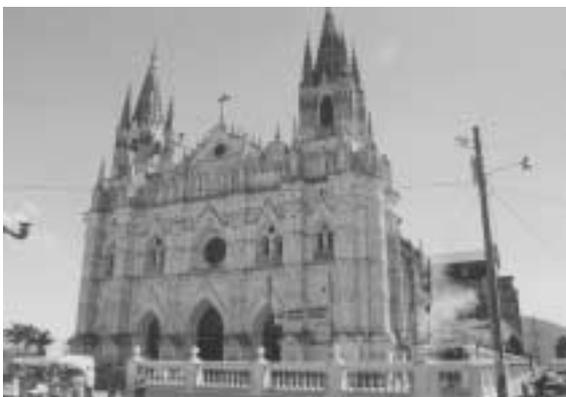
Photo 26. Slight damage to an un-reinforced masonry wall church in Santa Ana.

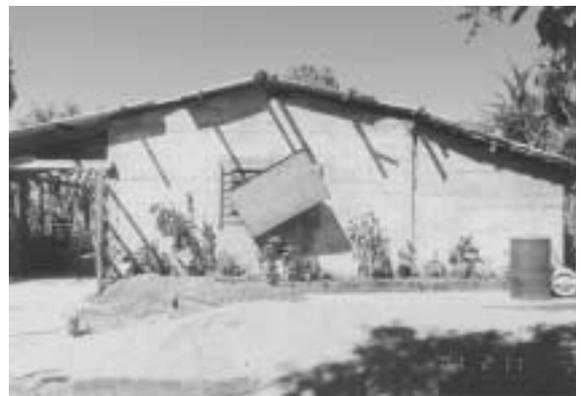
Photo 36. Damage to a confined masonry wall house in San Pedro Nonualco.

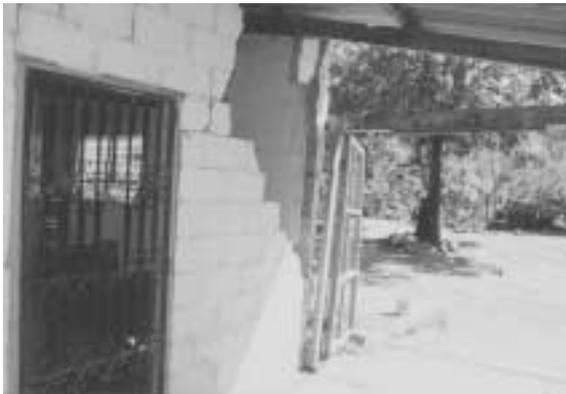
Photo 37. Failure of a hollow concrete-block masonry wall in the house in Photo 36. The hollow concrete block units are separated from the R/C confining column.

and 38) show where hollow concrete block walls and clay masonry brick walls were severely damaged. In the building in Photo 37, a concrete block masonry wall has separated into parts due to shear cracking, and part of the wall has separated from its adjacent R/C confining column and overturned in the out-of-plane direction. Also, shear cracks formed in the clay brick masonry walls of the building in Photo 38 have penetrated the R/C confining columns. This damage seems to have been caused by pounding from a collapsed building (upper right in Photo 38) rather than by ground shaking.

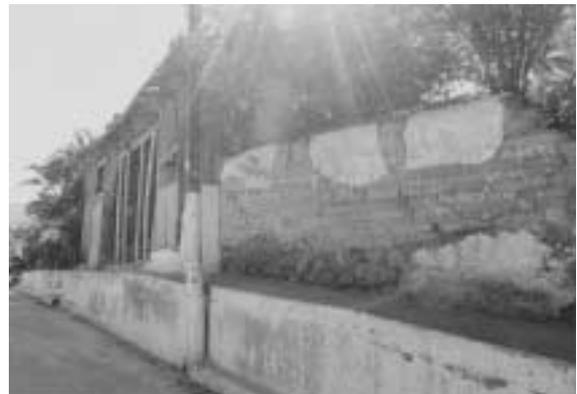
Photo 40. Failure of an adobe garden wall in San Pedro Nonualco.

A large number of masonry garden walls have been constructed of adobe, clay brick, or hollow concrete blocks throughout this country. Except for many built of adobe, most walls were not severely damaged. It should be noted that in El Salvador vertical wall reinforcements 40 cm apart are presented in most masonry garden walls comprised of hollow concrete block units. Damage to adobe garden walls consisted of sloughing off of finishes and the toppling of adobe blocks (Photos 39 and 40).

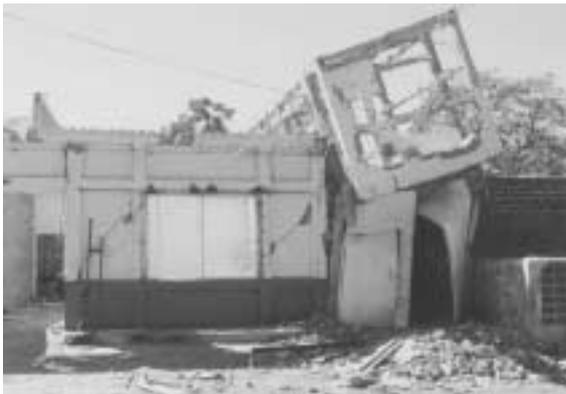
Photo 38. Damage to a confined clay-brick masonry wall in Usulután.

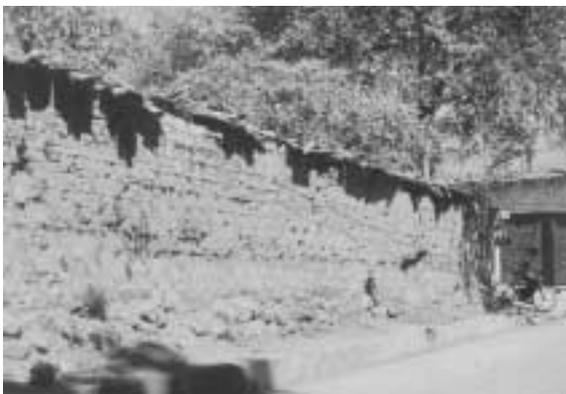
Photo 39. Damage to an adobe garden wall in Usulután.
