The September 2000 Torrential Rain Disaster in the Tokai Region: Investigation of a mountain disaster caused by heavy rain in three prefectures; Aichi, Gifu and Nagano

ABSTRACT

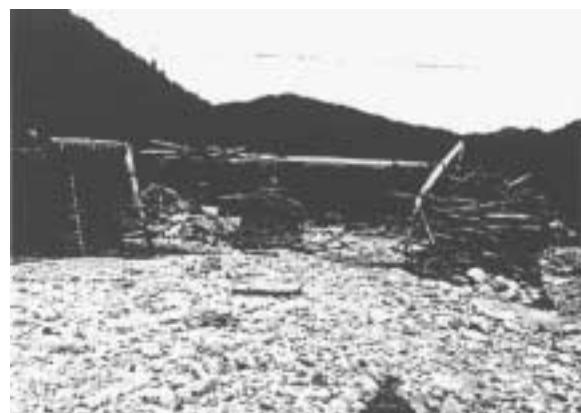
In the area where the total rainfall exceeded 400mm during this torrential rain, many civil engineering structures were damaged by mountain slope disasters and debris flows. A summary by the Gifu Prefecture Ena construction office of the damage to civil engineering structures is given in Table 1. Damage was most frequently caused by driftwood striking bridges and driftwood deposited in housing area. Results of resistance to the flow of streams due to the piling up of driftwood at the sides of bridges was observed at most bridge piers in the basin. Examples of bridge piers and bridge girders washed away are shown in Photo.1.

Photo. 1 Collapsed bridge washed away by the accumulated driftwood.

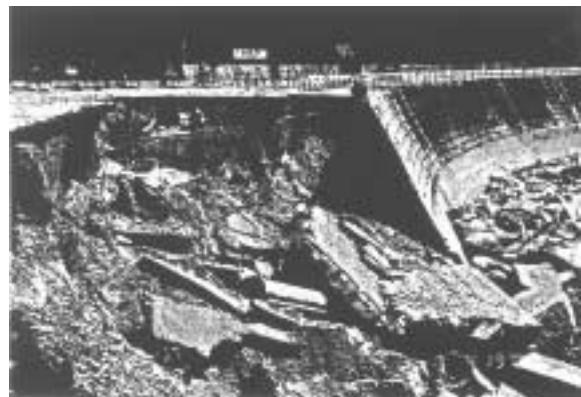
Photo.2 shows a failed revetment and the asphalt paving on a national highway. The main causes of the washing away of the revetment seem to have been the bulging in the river channel at the disaster position and local scour of the foundation ground by the flow in the stream.

Photo. 2 Collapsed road and revetment washed due to scour of the retaining wall base.

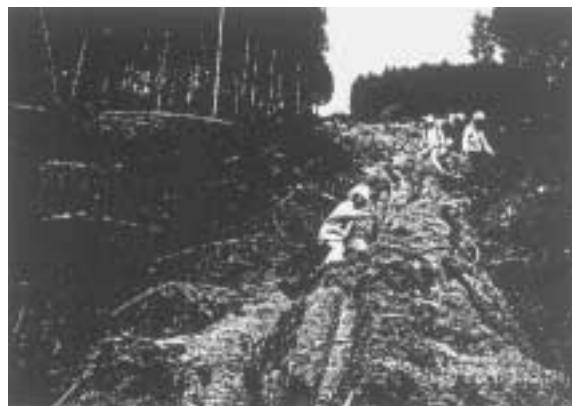
In Table 2, No.D1, destruction of a forest road is induced. In this case, the surface layer in the stricken area was mixed with the Masado layer of weathered granite rock and humus soil. There was gully erosion in middle of the slope at almost overall length. Photo.5 shows that this failed cross section was that of slope of the U type and afforested full face before it failed.

The existence of the 6.0m wide forest road which is in contact with the upper most end of the landslide scar is considered to have been the inducement for this slope failure. This forest road

became a sluice as rain water fall from it in to the watershed within about 200m of the highland. Water corrected at this site where there is a bend. The catchment area, as increased by the forest road was about $8.6 \times 10^3 \text{ cm}^3$ produced an increase of 34% in the catchment area of the same landslide scar. This also was an inducement to erosion because none occurred in the adjacent area that was without water inflow from forest road.

Photo. 5 Slope failure at Adera, Kamiyahagi Town, in which a forest road was an inducement (middle part of the slope).

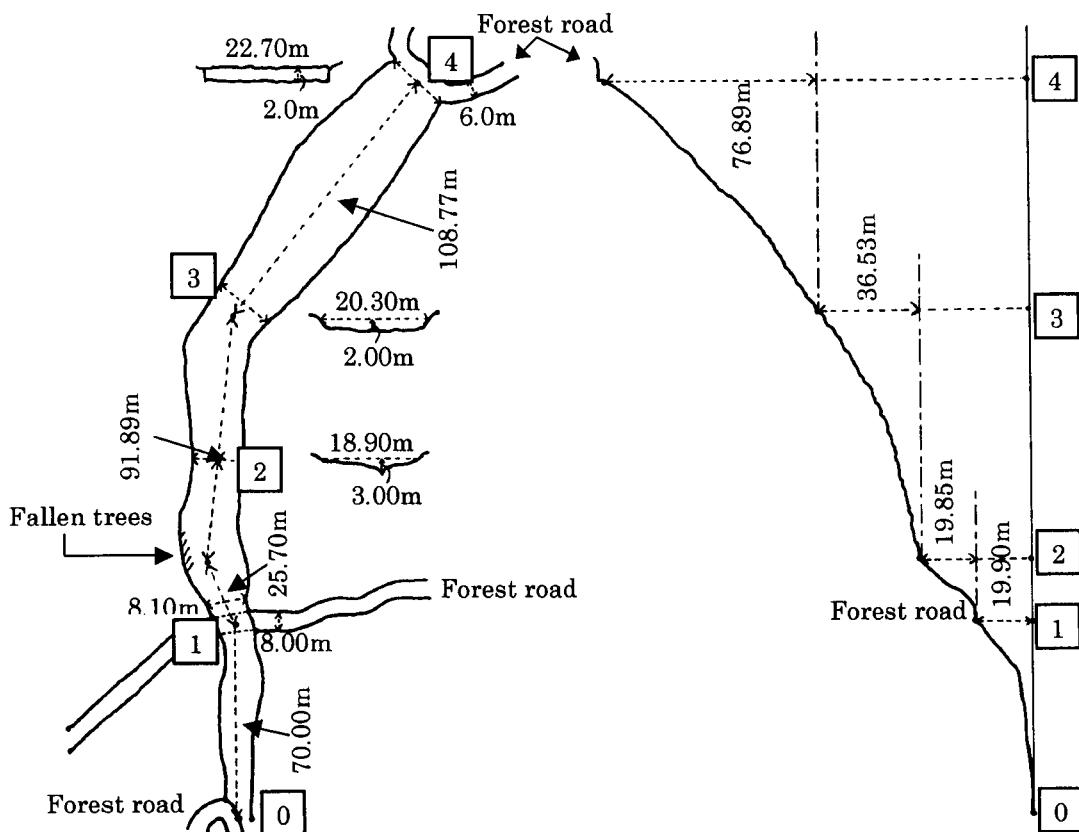
The topographic map for this collapsed ground is shown in Fig.4. Photographs were used simultaneously to determine the detail of the collapsed shapes. In the plan seen in this figure, cross sections are shown in which the gradient of differs at points. The longitudinal map shows the height of each interval, the lowermost

height of the forest road being the standard. It shows a 153m difference in elevation, 296m in horizontal distance, 337m in slope distance, a maximum width of 23m, largest tilt angle of 38° and largest collapsed depth of 3m. Valley erosion occurred for about 200m in this landslide area at the forest road in its lowermost part, and flooding deposited a layer of gravel in the farming area that was several meters high. Fallen trees with diameters of more than 80cm and length of 20m are present.

Fig. 4 Plan and longitudinal section of the failed slope in Kamiyahagi Town.

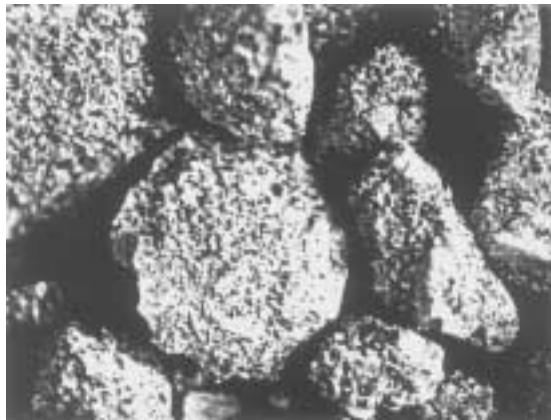
The constituent minerals of the surface soil as estimated by X-ray analysis are shown in Table 4. The particles consist of large amount of quartz and feldspar as the primary minerals, and may also contain gibbsite talc and a few clay minerals. Compaction of the surface soil therefore is assumed to be loose. An enlargement of the Masado layer is shown in Photo.7.

Photo. 7 Enlargement of strong wind granite (granite soil).
