Characteristics of Heavy Rainfall and Flood Damage in Aichi Prefecture from September 11th to 12th 2000

Haruhiko YAMAMOTO

Faculty of Agriculture, Yamaguchi University

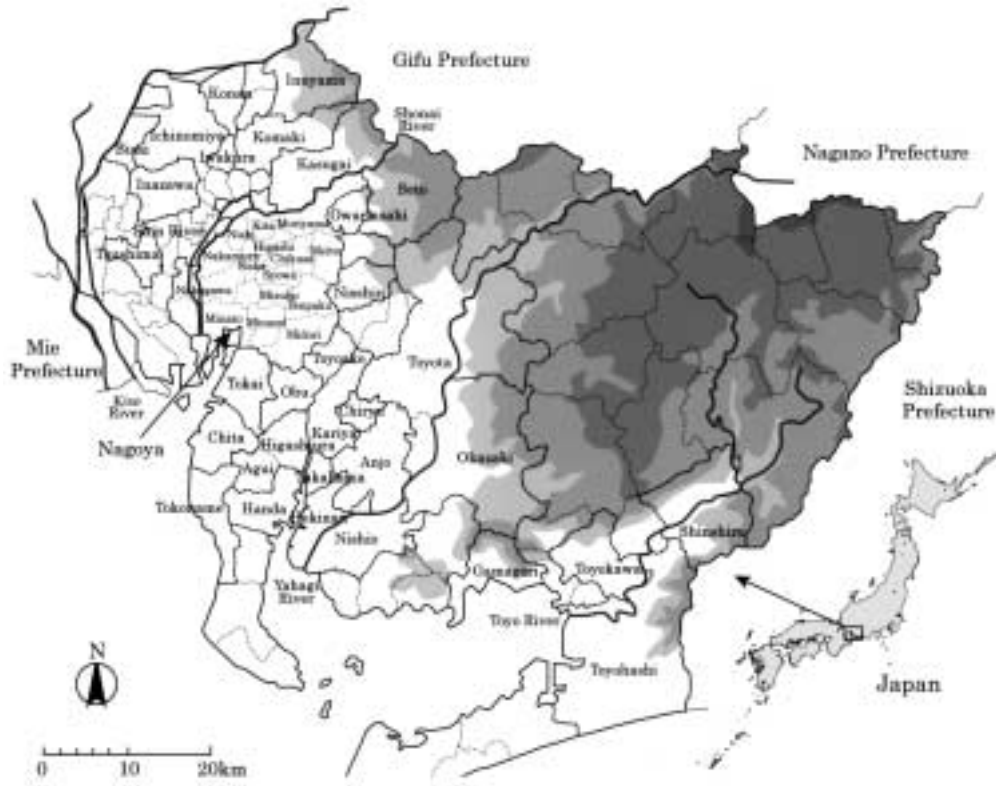
Fig. 1 Geographical position of Aichi Prefecture in Japan, the zone of cities, towns and villages in Prefecture, and city names, altitudes (100, 200, 500, 1000m) and river names.

The position of Aichi Prefecture in Japan, the zone with its cities, towns, and villages, the city names, etc. are shown in Fig. 1.

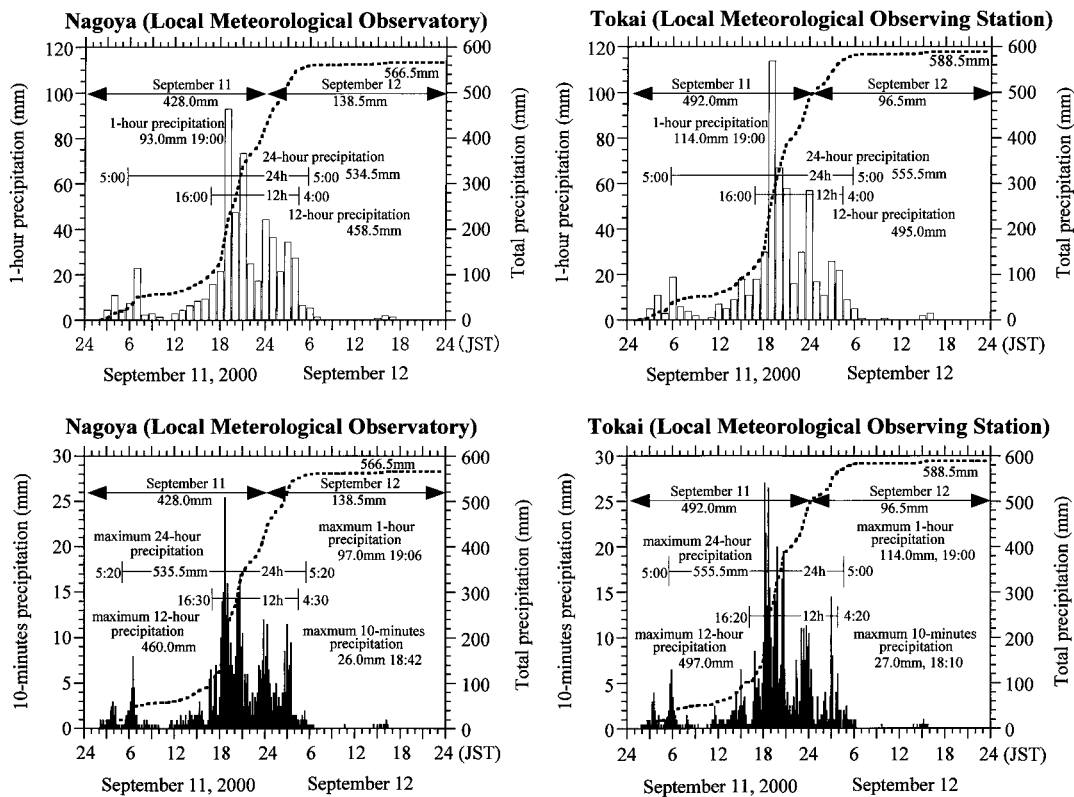
Fig. 3 Changes in 1-hour and 10-minute precipitation and the accumulated precipitation recorded at the Nagoya (Local Meteorological Observatory) and the Tokai (Local Meteorological Observing Station) facilities of the Meteorological Agency.

Local heavy rainfall occurred in Nagoya City and the surrounding region. Changes in the 1-hour, 10-minute, and accumulated precipitations observed in Nagoya (Local Meteorological Observatory) and Tokai (Local Meteorological Observing Station) of the Meteorological Agency from September 11 to 12, 2000 are shown in Fig.3. In Nagoya, weak rainfall began in the predawn of the 11th reached a maximum 20 mm/h then stopped during the morning. Rainfall began again around noon and increased in

The daily precipitation (September 11: 428.0mm, records started 1891), the maximum 1-hour precipitation (97.0mm, records started 1891), and the maximum 24-hour precipitation (534.5mm, records started 1971) in Nagoya were observed the 1st highest record. The maximum 10-minute precipitation (26.0mm) was the 2nd highest record, furthermore, the maximum 12-hour precipitation from 16:30 to 4:30 of the next day was 460.0mm. This precipitation is equivalent to 30% of the normal yearly precipitation (1,535mm).

In the Tokai (Local Meteorological Observing Station), located in Tokai City adjacent to the southern part of Nagoya City, the daily precipitation (September 11: 492.0mm), the maximum 1-hour precipitation (114.0mm), and the maximum 24-hour precipitation (555.5mm) recorded on the 1st. Furthermore, the maximum 12-hour precipitation from 16:20 to 4:20 of the next day was 497.0mm. Because of this heavy rainfall, at the 19 AMeDAS observation points in Aichi, nine points (the daily precipitation) and seven points (the 1-hour precipitation) recorded on the 1st.

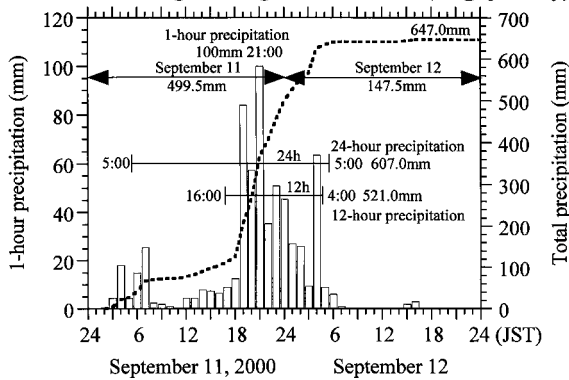
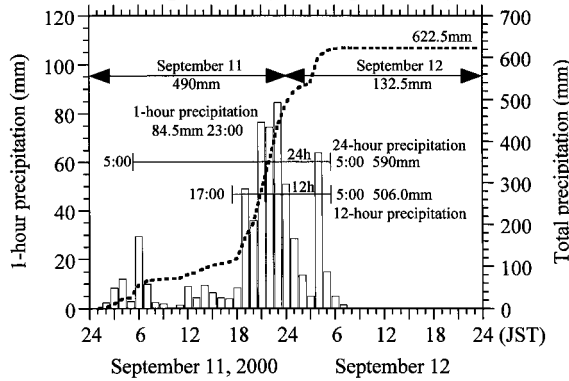
Fig. 4 Changes in 1-hour precipitation and the accumulated precipitations recorded from September 11 to 12 at the Midori Ward Engineering-Works Office, the Handa Fire Department, Higashiura branch and Agui Rainfall Observatory.

Rainfall conditions at 12 observation points at which the total precipitation on September 11th and 12th are shown in Table 2. Changes in the 1-hour, and accumulated precipitations from September 11th to 12th recorded at the Midori Ward Engineering-Works Office, Nagoya City, the Handa Fire Department, Higashiura Office, and the Agui Rainfall Observatory (Aichi Prefecture management) are shown in Fig. 4. At the Midori Ward Engineering-Works Office, first there was a weak rain peak from predawn to early morning on the 11th, then heavy rainfall with a 1-hour precipitation of 100mm, which continued into the early morning of the 12th. Daily precipitation on the 11th therefore was 499.5mm, on the 12th, 147.5mm, and the total precipitation 647.0mm. The 24-hour precipitation was 607.0mm (from 5:00 on the 11th to 5:00 on the 12th), and 12-hour precipitation 521.0mm (from 16:00 on the 11th to 4:00 on the 12th).

13km south of the Midori Ward Engineering-Works Office, precipitation was a little less than at the latter office, the total precipitation amounting to 622.5mm and the 12-hour precipitation to 506.0mm. Furthermore, the Agui rainfall observatory about 7km southwest of Higashiura had precipitation of 498mm on the 11th, 124mm on the 12th, and a 12-hour precipitation of 514mm. Total precipitation exceeded 600mm in seven places, and 12-hour precipitation exceeded 500mm in four places, making clear that record heavy rainfall had occurred over a wide area.

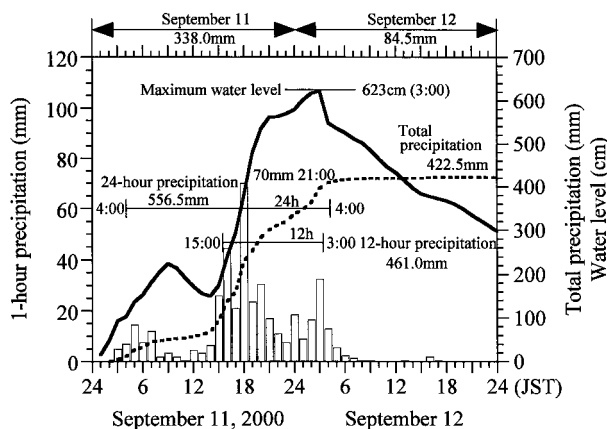
Fig. 8 Water level of the Shin River recorded at the Mizuba River Water Level Observatory, precipitation at the Nishikasugai Western Fire Department and accumulated precipitation value.

We made a field survey of the damage in these two places (Nishibiwajima Town and Nishi Ward of Nagoya City (Nakaotai area)), which suffered serious flood damage due to heavy. The water level of the Shin River recorded at the Mizuba River Water Level Observatory, the precipitation at the Nishikasugai Western Fire Department and the accumulated values are shown in Fig. 8. The rainfall, which began to lessen during the early morning of the 11th was recorded as 338.0mm on the 11th and 84.5mm on the 12th, total precipitation 422.5mm. Moreover, the 12-hour precipitation from 15:00 on the 11th was 461.0mm, and the 1-hour precipitation 70mm at 21:00. The water level of the Shin River rose rapidly from the afternoon of the 11th, the maximum of 623cm being recorded at 3:00 on the 12th. After the heavy rainfall ended, the water level of Shin River fell slowly.

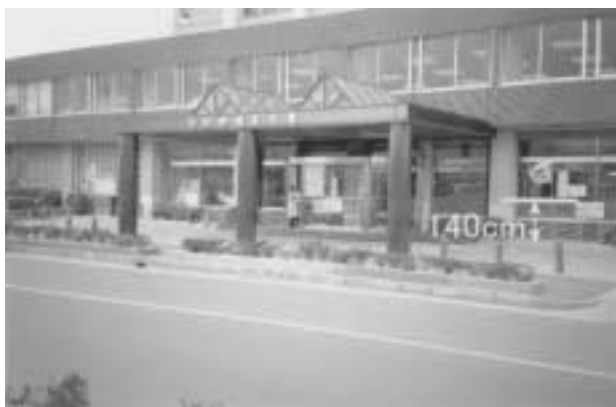
Photo 1. Flood mark on the glass of the door at the Nishibiwajima Town Office (Hanasaki-cho, Nishibiwajima Town).

The flood damage situation is shown in Photos 1-5. Photo 1 shows the flood mark on a glass at the Nishibiwajima Town Office. The 140cm flood mark was reached at that public office. Photo 2 shows the flood mark on the wall of the Meito dairy factory located northwest of the JR Biwajima Station. Here, flood mark is at 180cm, and marks exceeding 200cm are present around the factory. Photo 3 shows the flood mark under a bridge of the JR Tokaido Line. It is at 350cm, and the road has completely subsided.

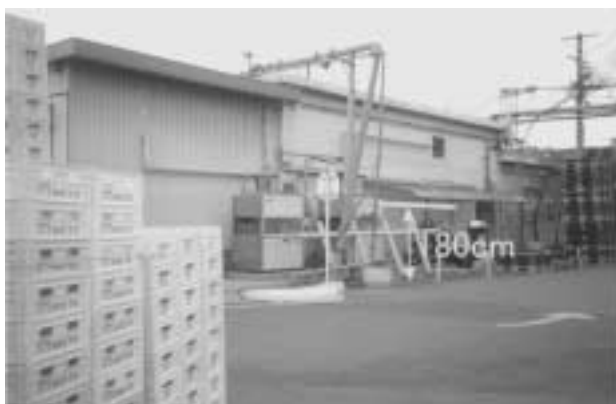
Photo 2. Flood mark on the wall of the Meito dairy factory located northwest of the JR Biwajima Station (Kaechi, Nishibiwajima Town).

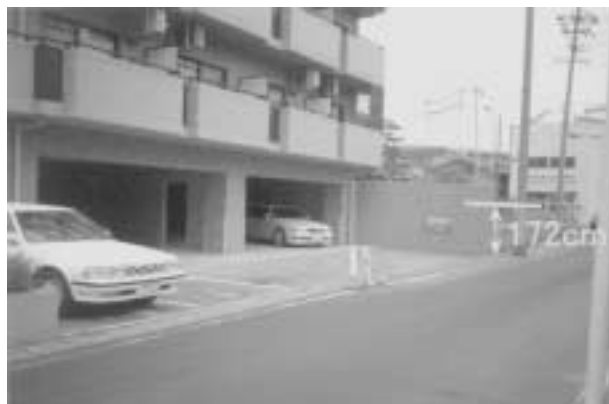
Photo 4. Flood mark on the wall of an apartment building located south of the JR Biwajima Station (Asahi-machi, Nishibiwajima Town).

Photo 4 shows the flood mark on the wall of an apartment building located south of the JR Biwajima Station. Although the depth of flooding is 172cm, because the ground floor of the building is a parking lot, there was no flooding of the apartments above that level. Photo 5 shows the flood mark on the wall of the building belonging to Takaoka Electric Factory located about 500m west of Futatsui Station on the Nagoya Railroad Nagoya line. Flood exceeding 200cm was recorded nearby, the deepest flooding in the entire area investigated. Serious damage also was caused by flooding at the Nagoya factory of Mitsubishi Heavy Industries located north of Futatsui Station.

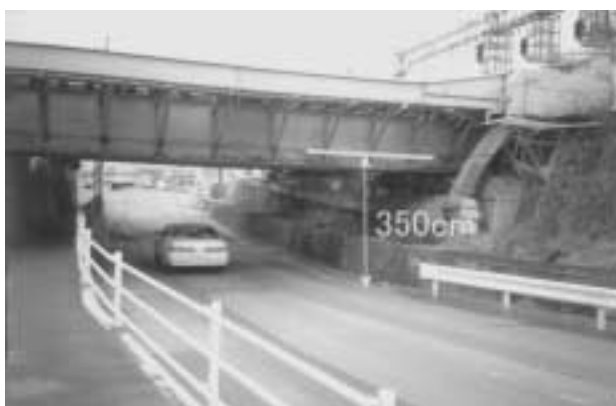
Photo 3. Flood mark under a bridge of the JR Tokaido Line (Yowa, Nishibiwajima Town).

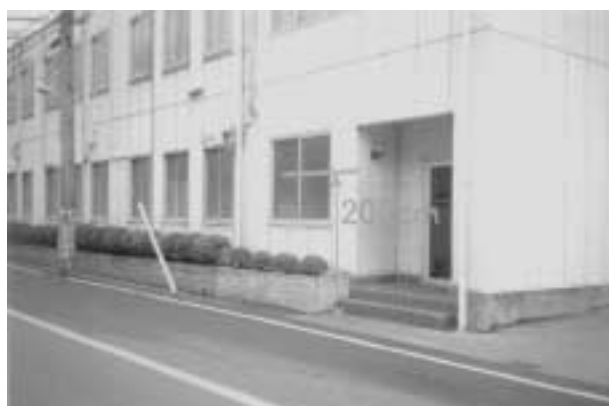
Photo 5. Flood mark on the wall of the building of Takaoka Electric Factory located about 500m west of Futatsuri Station on the Nagoya Railroad Nagoya line (Yoshino-cho, Nishibiwajima Town).
