Microtremor Measurements and Building Damage during the Changureh-Avaj, Iran Earthquake of June 2002

ABSTRACT

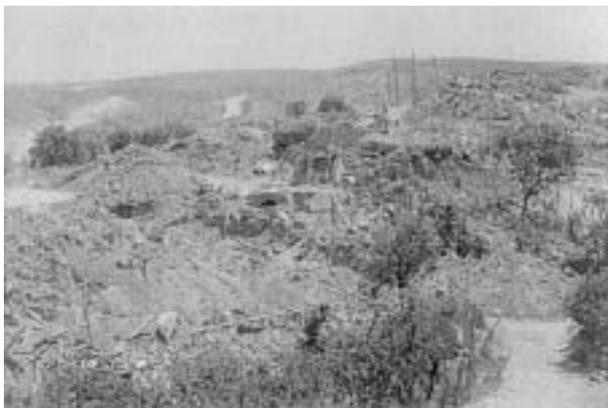
Photo 1 Collapsed adobe buildings which had arched and/or timber roofs (Abdareh)

Old adobe buildings were used not only as residential units but as warehouses and sheepfolds. The construction of these low quality adobe buildings consisted of mud-brick bearing walls that supported a flat slab or an arch floor slab. Stone was an alternative material used for bearing walls in villages near mountains. Flat slabs were constructed with wooden beams thatched with mud-straw materials, whereas arch slabs built of mud-brick bonded with mud-grout. The seismic performance of such non-engineered dwellings is a function of wall thickness, internal subdivisions, roof mass, nature of the continuity with adjacent dwellings, distance to the fault, and site effects. Photo 1 shows failed adobe buildings with arch floor slabs and/or wooden flat floor slabs.

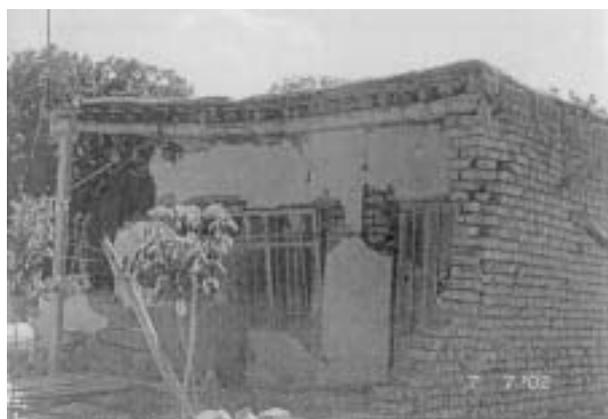
Photo 2 A thatched timber roof bonded with asphalt (Tablashkin)

Un-reinforced masonry (URM) structures suffered severe damage during the earthquake. Unfortunately, masonry is the most commonly available and economical construction material, and individual owners have used it throughout the region. Photo 2 shows a typical damaged URM building with a timber roof.

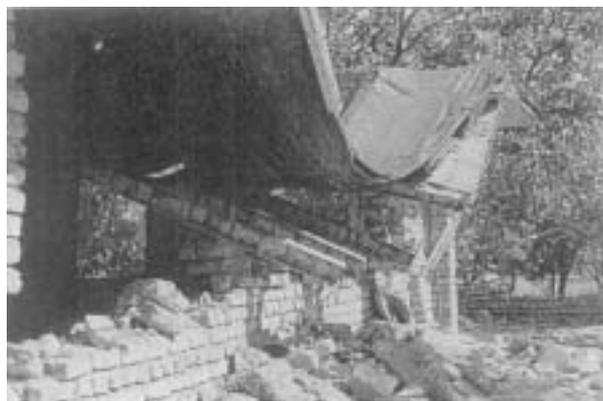
Photo 3 A typical collapsed URM building with a Jack-arch floor slab (Changureh)

ing walls, but reliance on a floor with brittle URM bearing-walls to resist lateral forces ensures that once the strength threshold is exceeded, severe damage and/or dramatic collapse is likely to occur. In-plane, out-of-plane, and combined in-plane and out-of-plane failures occurred, as is normally expected with URM structures. Photos 3 and 4 show collapsed URM structures with steel-masonry Jack-arch slabs.

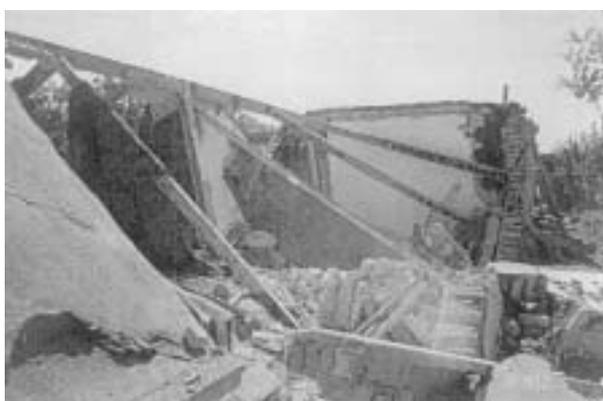
Photo 4 Collapse of a URM building with a Jack-arch floor slab (Changureh)

Brick and mortar quality have a major influence on the in-plane performance of URM structures. The use of solid bricks bonded with mortar in URM bearing walls that have a thickness of 350-mm seems to be sufficient to prevent out-of-plane failure in typical single-story URM structures. Out-of-plane failure of URM bearing-walls was, however, the principal cause of the collapse of URM structures. The use of poor mortar resulted in unstable walls when buildings were subjected to out-of-plane seismic force. Moreover, the absence of any anchorage at roof level between the bearing walls and slabs compounded the problem, causing even greater damage (Photo 4).

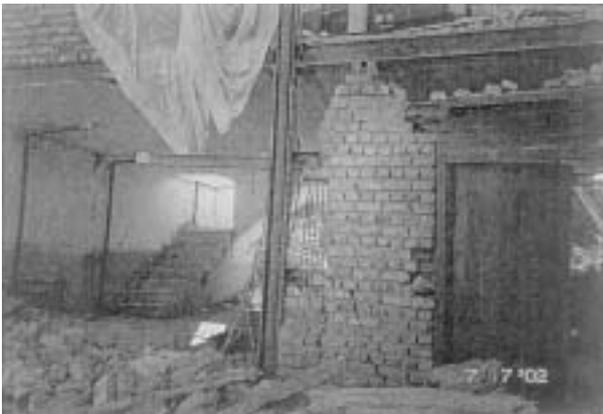
Photo 5 A surviving semi-steel structure with a Jack-arch floor slab (Changureh)

Photo 5 shows a two-story, semi-steel structure with steel columns and beams. This building had a relatively light roofing system. Steel beams and columns were used to support the gravity dead load and live load. Obviously there was no lateral resistance system. The presence of reinforcement that tied the infill walls to

the columns prevented out-of-plane failure of the infill walls, resulting in a semi-lateral resistance system. This system together with the light roof prevented complete collapse. The building, however, could no longer be occupied, and reconstruction was necessary because of severe deformation of its beam-to-column connections.

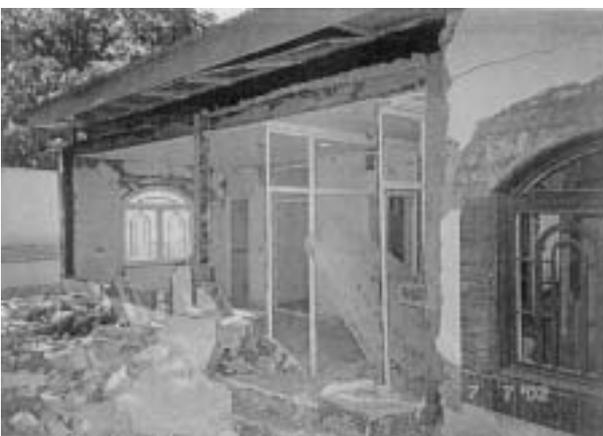
Photo 6 Out-of-plane failure of the infill of a semi-steel structure house (Changureh)

Out-of-plane failure of the infill walls was frequent in these types of semi-steel structure systems. Photo 6 shows an example in which the horizontal and vertical steel ties were constructed according to the Iranian Seismic Code. The building itself survived, but failure of the heavy un-reinforced infill walls caused a vast human damage.

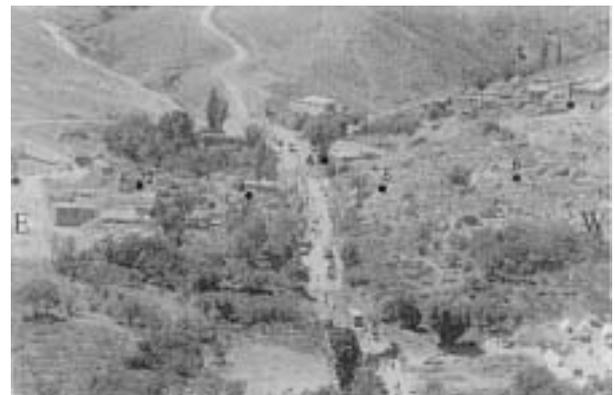
Photo 7 Microtremor measurement station sites in Abdareh (Photo: Majid Noorallahpoor, Iran)

In Abdareh, tremors were measured on the ground surface at 7 stations, whose positions are roughly indicated in Photo 7. Actually, station No. 1 is much further to the left than shown in the Photo, and is behind a large, engineered-built house which suffered slight damage to its masonry walls. No.4 is in front of an undamaged, stiff public bath (Photo 8), No. 7 is nearby some 50%-dam-

which had the lowest predominant period, 0.06 s, has the hardest ground surface of all the sites, which is in good agreement with the earthquake-induced damage, because in that area of Abdareh alone, some adobe houses survived (Photo 7). Another factor in damage interpretation is the taking into account of the dynamic characteristics of structures. A forced vibration test therefore was conducted on an adobe house in Tablashkin Village.
