Damage to the Railway System along the Coast Due to the 2011 Tohoku Earthquake Tsunami

Soichiro SHIMAMURA*
Fumihiko IMAMURA**
Ikuo ABE***

*Department of Civil and Environmental Engineering, Tohoku University
6-6-11-1106, Aoba, Sendai, 980-8579, JAPAN

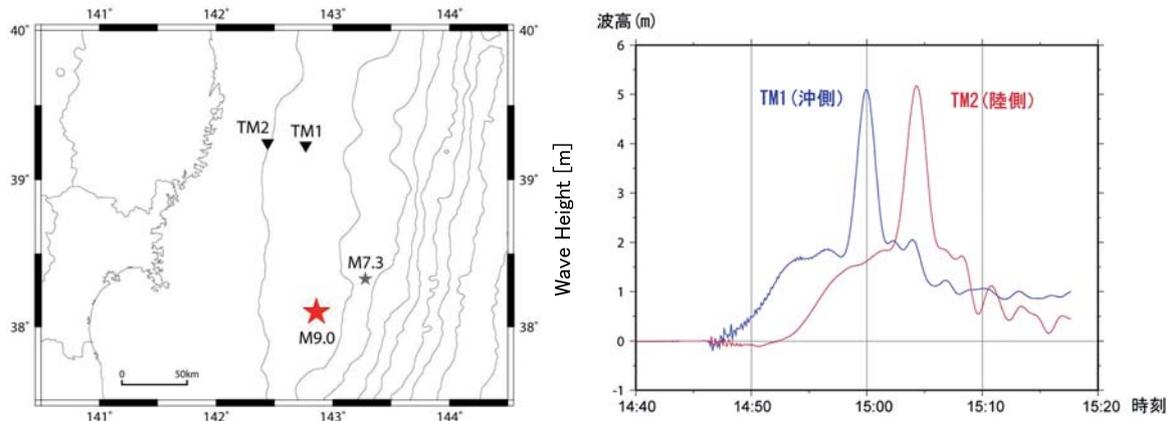
Fig. 1. Sea-level change recorded by the ocean floor cable seismometer off of Kamaishi (Earthquake Research Institute, The University of Tokyo)

As described above, the 2011 Tohoku Earthquake Tsunami of Mw 9.0 caused enormous damage to most areas of the Pacific Ocean coast. Within a broad flood area (about 560 km²), the tsunami caused the collapse of reinforced concrete structures and the outbreak of fires. The waveform of the offing (Fig. 1) is an important feature of tsunami action. On March 11th, immediately after the main Mw 9.0 shock, three consecutive Mw 7 aftershocks occurred, causing an increase in wave height in two stages, as shown in the graph

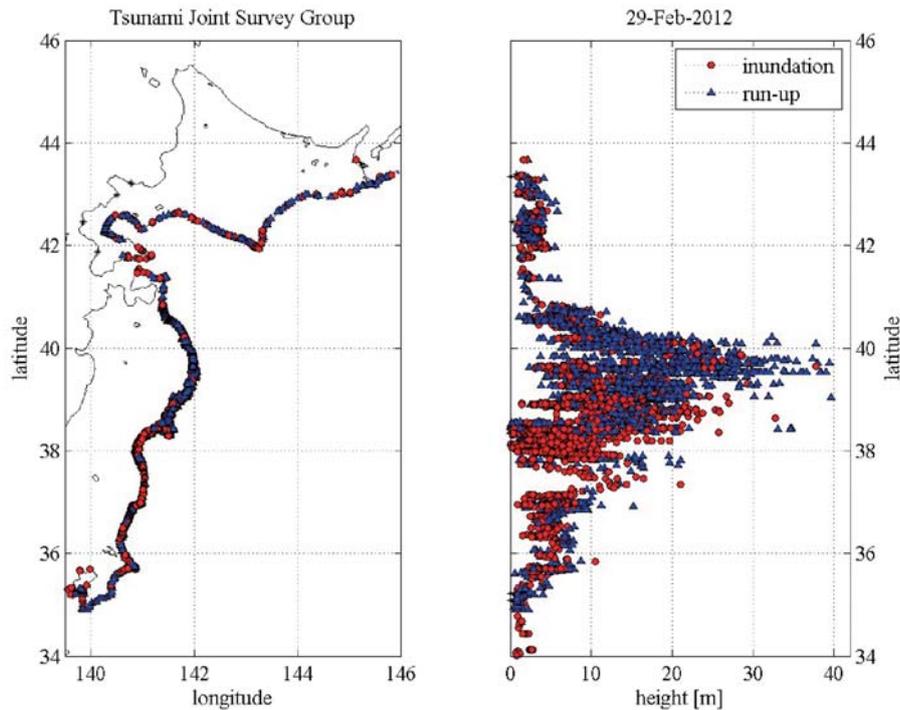
Fig. 2. The field survey result projected in the direction of latitude (The 2011 Tohoku Earthquake Tsunami Joint Survey Group)

on the right (Fig. 1). These shocks caused a very high tsunami in the area along the shore, and evidence of the great height of the tsunami can be seen in various places (Fig. 2). In particular, along the Iwate ria coast, the run-up height was nearly 40 m.

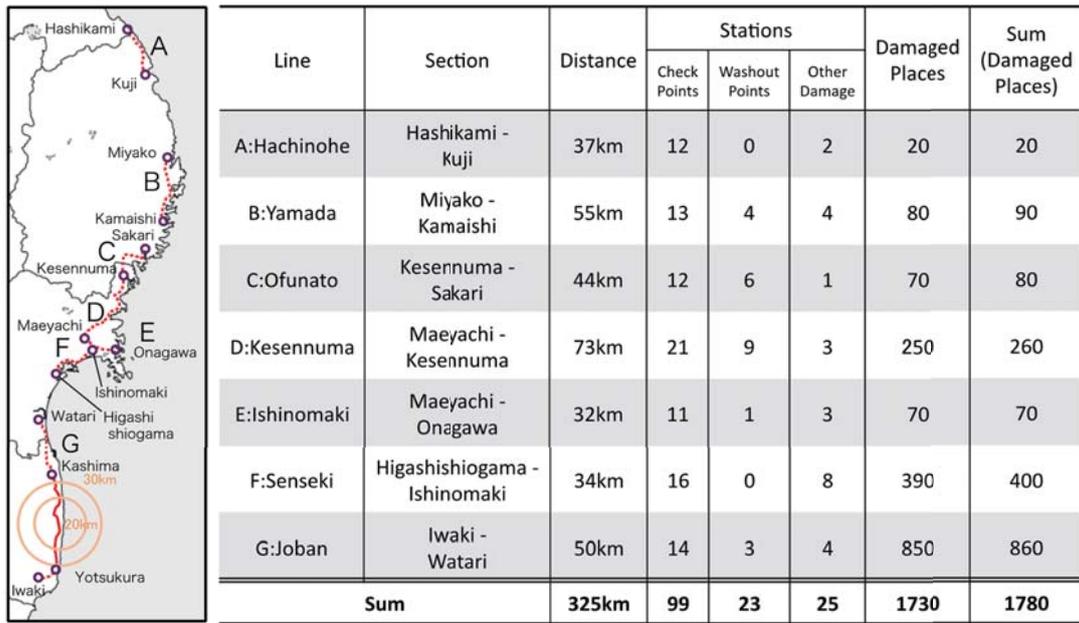
Fig. 3. Damage to railway caused by the tsunami (JR East)

This tsunami, with the greatest wave force ever and causing the greatest area of flooding also seriously affected the railway. Figure 3 shows damage in the JR East province. The form of damage, including damage to electrification pillars, displacement of the railway track, washout and burial of bridge beams, failure of signal and communication equipment, and

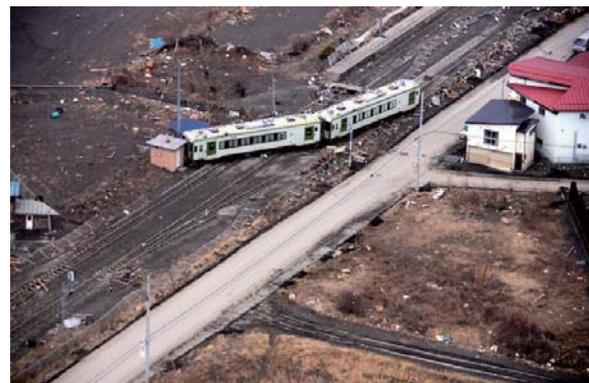
The interrupted section of the Yamada Line is the longest in the nine main disaster-affected routes, and the route passes through areas that were enormously damaged by the earthquake disaster, such as Yamada town and Otsuchi-Cho along the railway line. At Tsugaruishi Station, while the train for Miyako Station stopped, it was affected by intense shaking. As the tsunami alarm from the operation management center was sounded promptly, the passengers evacuated to nearby Tsugaruishi Elementary School, but, because the tsunami reached the elementary school, they then evacuated to safety on the hill behind the school. According to JR staff, at approximately 15:20, the train was washed along in the Toyomane Station direction from Tsugaruishi Station, and it drifted approximately 80 m along the railway line from where it had stopped. The tsunami numerical analysis also shows that the tsunami arrived

at Tsugaruishi Station, which is approximately 1 km from the coast.

Photo 1. Yamada-Line • St. Tsugaruishi (Provided by JR East)

In this report, the fall of trains caused by the tsunami was examined and the archived data and the results of tsunami numerical analysis were compared. However, Nagase (2011) notes that the diesel train that was stopped at Tsugaruishi Station might have floated and drifted for a long time. For most of the trains that were damaged by this tsunami, their behavior, such as rolling, sliding, and floating, is not known, but it is certain that they drifted several tens of meters. In Nagase (2011), the train might have floated because the waterline trace (1.76 m) left on this train was smaller than the trace (2.58 m) that remained at the station where this train was stopped, so he set “Floating Limits” from the balance of the mass of the train and the buoyancy due to the seawater. The result was 1.7 m. However, this analysis is only applicable to the sealed train model. A graph superimposed on the Floating Limits of the time-series wave height of the analysis result is shown in Fig. 9. Figure 9 shows that a wave height greater than 2 m occurred for a long time according to the pattern where the shore structures are considered, and it approached the Falling Limits earlier than the Floating Limits. However, this train approached the Floating Limit earlier than the Falling Limits and drifted because it could not fall down before floating by tsunami because there is no trace of contact with the train in the station yard where it stopped when the earthquake occurred, according to the field survey. Thus, an evaluation

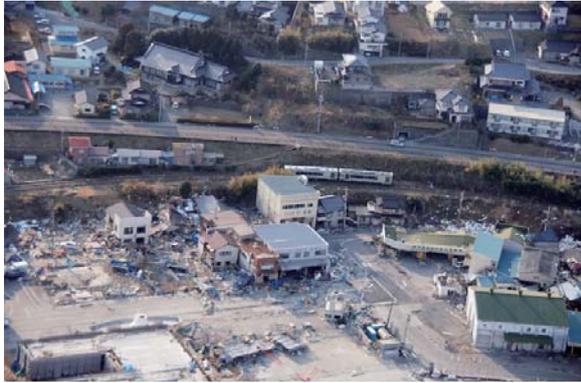
Along Ofunato Line, a train with a two-car formation was heading to Shimofunato Station from Ofunato Station at the time the earthquake occurred. Although the train came to an emergency stop at a location that was several meters higher than the surrounding land, the crew who received the evacuation directive helped the passengers down and proceeded with evacuation. They did not evacuate to Ofunato Elementary School, which is the designated evacuation building, due to the advice of a local passenger but rather went to Ofunato Junior High School, which

is the same distance from the train as the elementary school but at a higher altitude. As a result, although the tsunami reached the schoolyard of the elementary school, they evacuated safely to the junior high school. The train, which had come to an emergency stop, was approximately 240 m from the coast and was spared derailment and drift, but the train chassis was covered with water and the train was immobile.

Photo 2. Ofunato-Line • Ofunato-Shimofunato
(Provided by JR East)

nato, the only damage was due to the flooding of the train chassis by the tsunami, and the flooding depth reached 3.2 m in the case without the shore structure and did not reach 1.1 m in the case with the shore structure. In other words, the agreement with the real damage was because possibility that the inundation was only 1.1 m in two cases could not be denied, indicating the lower limit and the upper limit of the true phenomenon. However, for the inundation depth along the railway track, this analysis result is overestimated because the height of the railway track, which is the height of the railroad embankment, cannot be considered. Furthermore, Table 1 shows the tsunami arrival time and the influence start time (the falling limit time) determined from the time-series wave height at the train damage points. At Nobiru – Tona, Onagawa and Matsuiwa – Saichi Stations, the tsunami arrival time and the influence time were not signifi-

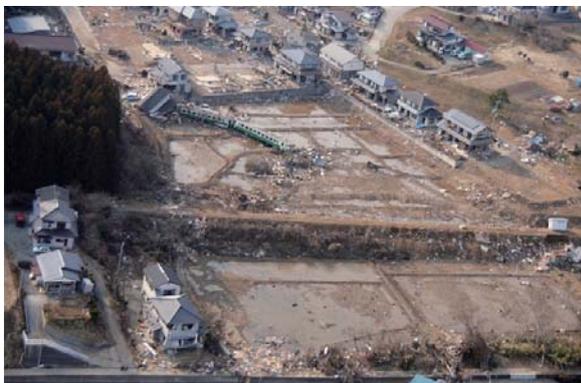
A train with a two-car formation to Kogota was running between Matsuiwa and Saichi when the earthquake occurred. After the train made an emergency stop, the train driver received the tsunami alarm, had the passengers disembark and started the evacuation. It was necessary to walk approximately 200 m along the railway track, and the train driver saw the sea level decrease suddenly and evacuated at a hurried pace to the Junior High School, which is situated approximately 1 km inland. Although the passengers and the

Photo 3. Kesenuma-Line • Matsuiwa-Saichi
(Provided by JR East)

crew were safe, the train was derailed and drifted approximately 60 m in the direction of the tsunami.

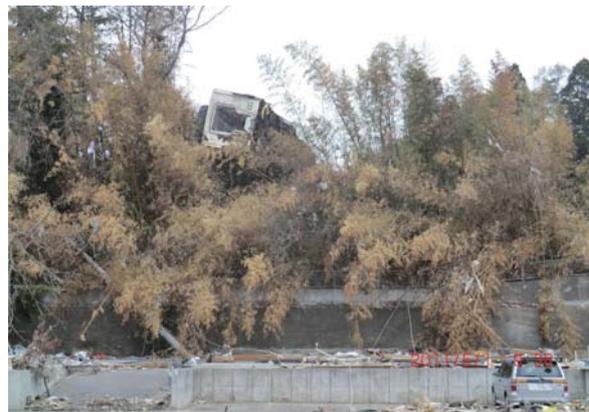
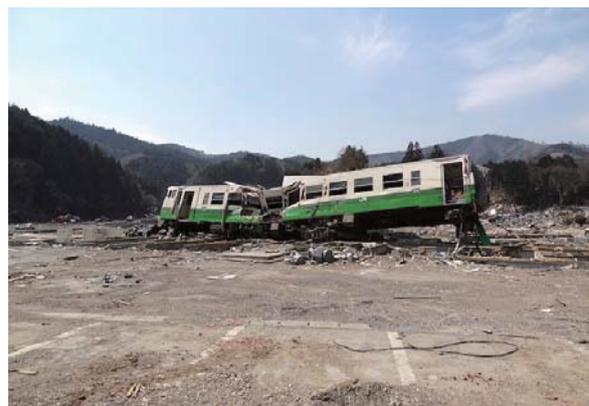
Along Ishinomaki Line (the whole line section (44.9 km)), the damaged section was only 700 m from Onagawa Station to Onagawa Tunnel but suffered crushing damage from the shape of the bay.

A train with a two-car formation was at rest and ready for departure in Onagawa Station yard when the earthquake occurred, but this train and the train used by some hot spring institutions were carried away by the tsunami. Among the trains in the two-car formation that drifted, one train drifted approximately 200 m and was completely destroyed, and the other train drifted 100 m more inland and stopped at a graveyard on a hill. In addition, damage to the station building and the railway track were serious, and both were severely damaged.

Photo 4, Photo 5. Ishinomaki-Line • around St. Onagawa

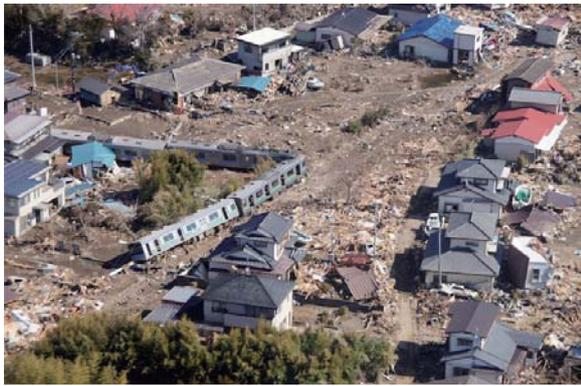
Photo 6. Senseki-Line • Tona-Nobiru
(Provided by JR East)

commuters and school goers. Two trains were running when the earthquake occurred in this area, and one of them was the train to Aoba-Dori Station. The passengers evacuated according to the instructions of the crew to Nobiru Elementary School, which was the nearby evacuation building, but the tsunami reached this elementary school. Immediately afterwards, the train was derailed by the tsunami, turned at a right angle and stopped when it hit a house behind it. Another train (Photo. 7) for Ishinomaki that was stopped at this place went ahead approximately 1.5 km in the Ishinomaki direction from the train that was derailed. This train was stopped on a hill that was a little more than 10 m high. The crew decided to stay in the train with the passengers on the advice of local people, and they escaped the tsunami and were safe. The difference of a slight distance and a slight altitude are clearly distinguished by the light and shaded areas.

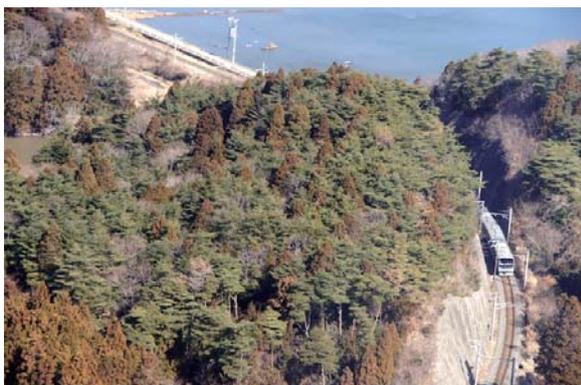
Photo 7. Senseki-Line • Tona-RikuzenOno
(Provided by JR East)

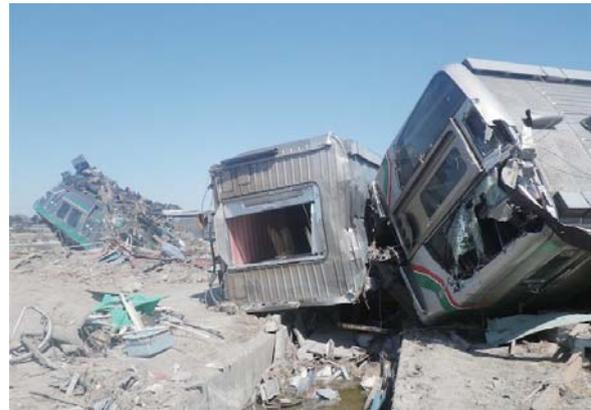
main factors included the explosion at Fukushima First Nuclear Power Plant, but the damage caused by the tsunami was too serious. In particular, a train that was stopped and the station building at Shinchi Station of Fukushima were destroyed. In addition, there was damage to a freight train on the Joban Line. Between Hamayoshida to Yamashita, all of the containers that had been piled up were washed away and collided with private houses, and they were a factor in the extent of the damage. The damage to Sendai Airport access lines and North Rias Line, South Rias Line and Hachinohe Line were confirmed in other reports.

Photo 8. Joban-Line • St. Shinchi

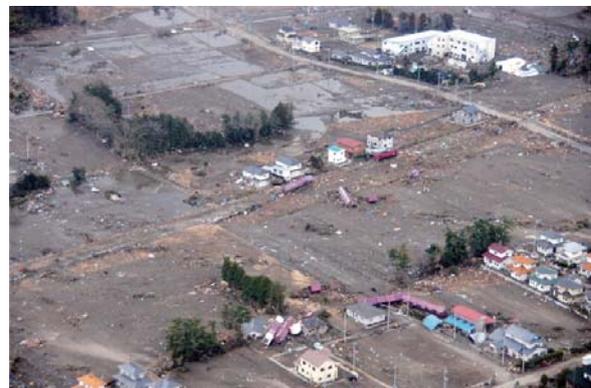
Photo 9. Joban-Line • Hamayoshida-Shimoyama
(Provided by JR East)

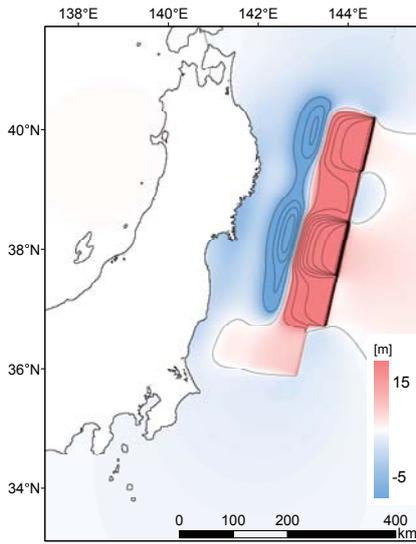
Tsunami numerical analysis was performed for each disaster area to examine the mechanism of the train damage caused by the tsunami, which is given in detail in the previous section. As described above, the seismic deformation model uses the Tohoku University model version 1.0 (Fig. 4). For the calculation conditions, a shallow water theory that integrates the

Fig. 4. Tohoku University model (Version 1.0)

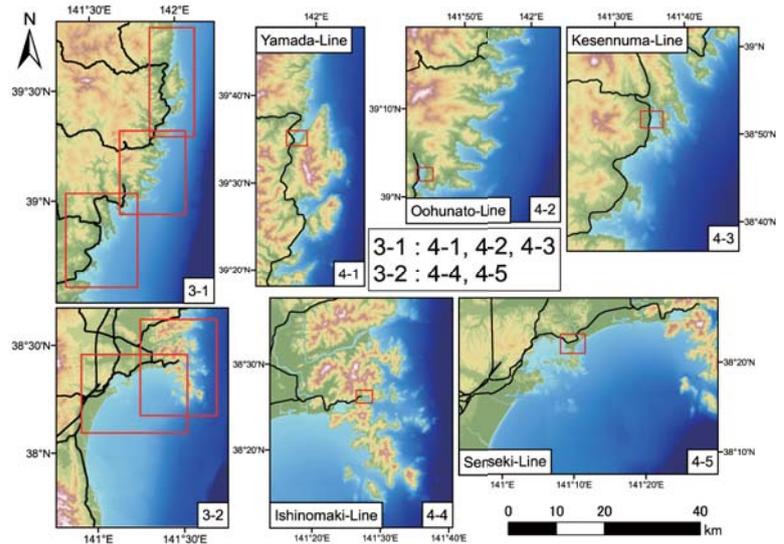
Fig. 5. Computational region

The analysis results are shown in Fig. 7 and Fig. 8. Figure 7 shows the maximum inundation map in the train damage area (red frames of Fig. 5) in each region in two ways, including the shore structure and not including the shore structure. In addition, the mesh where the maximum inundation depth exceeded the Falling Limits (1.1 m) is shown in red, and less

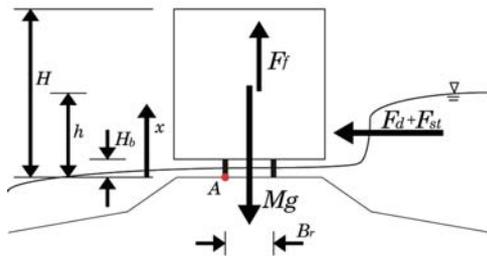
In addition, the damage was measured using a model (Fig. 6) that expresses the falling limit of the train caused by the tsunami with the balance of the moment. I used the tsunami force (F_t) calculation

Fig. 6. Fall moment model

method described in H. Yeh (2007) in this model, which has been examined previously and expresses the fall limit of the train caused by tsunami using only the inundation depth.

$$F_t = F_{st} + F_b + F_d$$

$$F_{st} = \rho g B L h, F_b = \rho g L h^2, F_d = \frac{1}{2} \rho C_d L (h u^2)_{max}$$

$$\frac{(h u^2)_{max}}{g R^2} = 0.125 - 0.235 \frac{z}{R} + 0.110 \left(\frac{z}{R}\right)^2, h + z = R$$

F_{st} : Hydrostatic Forces, F_b : Buoyant Forces, F_d : Hydrostatic Forces, ρ : fluid density [kg/m^3], g : acceleration of gravity [m/s^2], B : width of train [m], L : length of train [m], h : inundation depth [m], u : velocity [m/s], C_d : Drag Coefficient(=2.0), R : runup height [m]

This value is referred to as the ‘‘Falling Limits’’ and it was calculated to be 1.1 m. The precision of the ‘‘Falling Limits’’ was checked by comparison with the train damage archive.

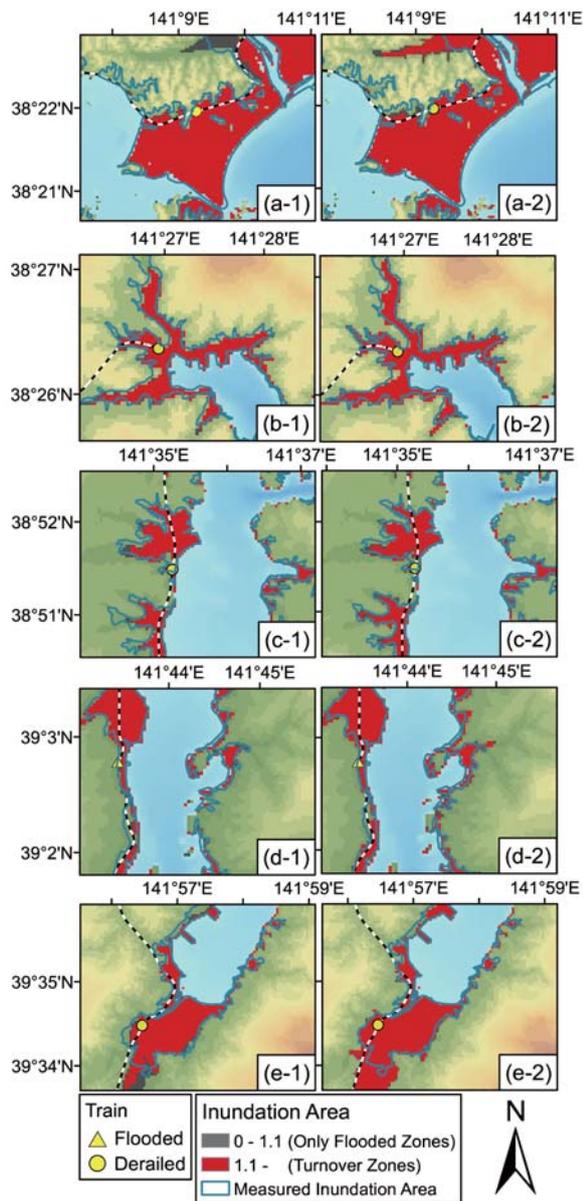
Fig. 7. Maximum inundation map (a:Senseki-Line, b:Ishinomaki-Line, c:Kesenuma-Line, d:Ofunato-Line, e:Yamada-Line, -1: with a shore structure, -2: without a shore structure)

than this limit is shown in gray. Most of the inundation area in the region analyzed here exceeds 1.1 m. The graph in Fig. 8 shows the time-series wave height at each train damage point. As described above, the true phenomenon depends on whether there were shore structures, but the inundation was over the Falling Limits (1.1 m) regardless of the presence of shore structures at the points where the derailment and fall of the train were due to the tsunami, except along Ofunato – Shimofunato Line. In Ofunato – Shimofu-

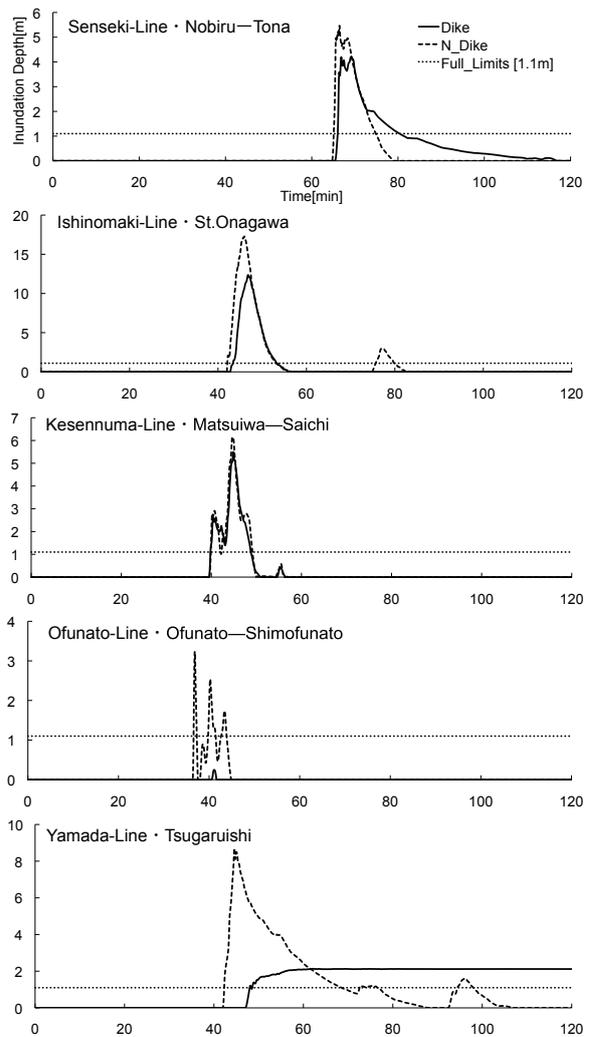
Fig. 8. The time-series wave height

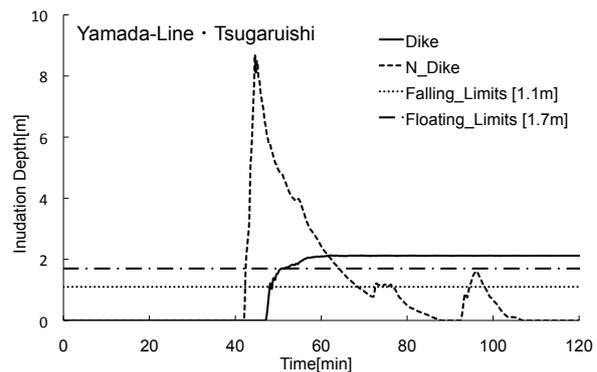
method for the train damage mechanism that uses only the inundation depth is limited, and it is necessary to establish a detailed evaluation method that takes into account the velocity, flow direction, among others. However, the evaluation method that uses only the inundation depth is very useful because it has the advantages of versatility and being easy to fit with existing predictive inundation maps.

Fig. 9. The time-series wave height (Falling Limits & Floating Limits) In the figure above, change Inudation to Inundation

Nagase (2011), who considered the train behavior at Tsugaruishi Station as the train damage point, suggested that the Floating Limit at which the train floats due to the tsunami is 1.7 m and assumed that floating occurred before falling. This study limitedly examined train damage by considering the inundation depth alone, and thus further examination of the damage mechanism taking into account the velocity and flow direction is necessary.
