The September 2000 Torrential Rain Disaster in the Tokai Region: Investigation of a mountain disaster caused by heavy rain in three prefectures; Aichi, Gifu and Nagano

ABSTRACT

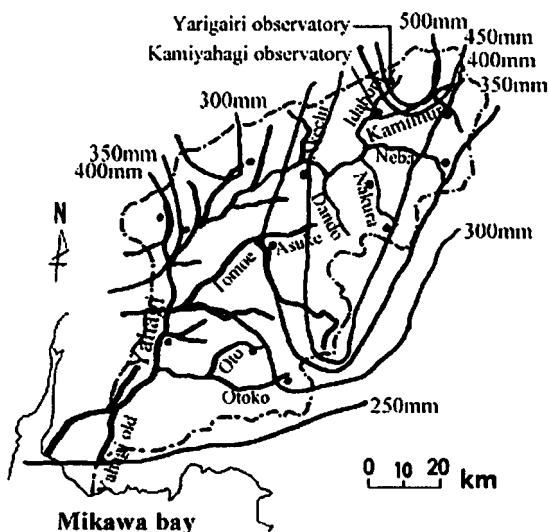
Fig. 1 Total rainfall for the Yahagi River system.

As seen from Fig.1, an area with 500mm total rainfall is centered mainly on Kamiyahagi Town, Gifu Prefecture. This area of severe rainfall covers a narrow region from the north of Aichi Prefecture to the south of Nagano Prefecture. This heavy rain produced a record-breaking amount of rainfall at both observatories. In particular, the maximum hourly rainfall at the Yarigairi observatory was 80mm, and the total rainfall 595mm between 11 p.m., September 11th and 0 a.m., September 12th. The maximum hourly and total rainfalls at the Kamiyahagi observatory respectively were 65mm and 437mm. The Ministry of Land, Infrastructure and Transport reported that these amounts set records in the past 500 years.

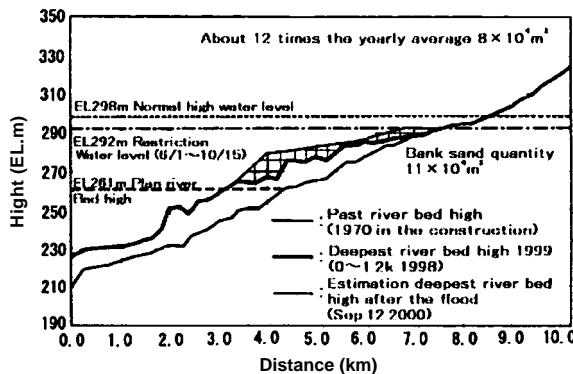
Fig. 3 Bank sand quantity curve, the Yahagi Dam inflow division. (Ministry of Land, Infrastructure and Transport Chubu District improvement station material [2000]).

rate (80,000 m³). The estimated quantity of banking sand that flowed into Yahagi Dam is shown in Fig.3.

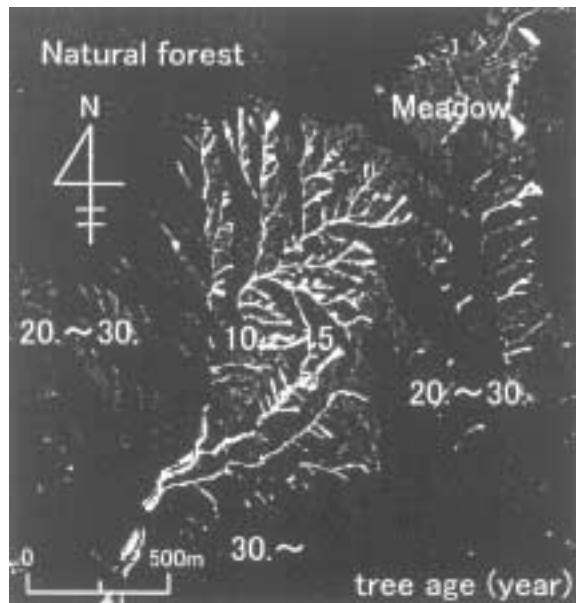
Fig. 5 Trees planted near Ina County, Neba Village, Nagano Prefecture.

Fig.5 shows that slope failure mainly occurred on the southwest as compared to the northeast side of the slope. This phenomenon is explained as follows: 1) Though the erosion progressed on stumps which remained after the clear-cutting, its progress on southwest side was more rapid than on the northeast one due to sunshine and the temperature gradient at ground level. 2) After the 15 years that have passed since the tree clearing, the slope direction has affected progress of erosion, and the number of slope failures generated differ according to the direction of the slope. Moreover, it is said that "the surface in the area with the erosion stumps is soft like the thick carpet".

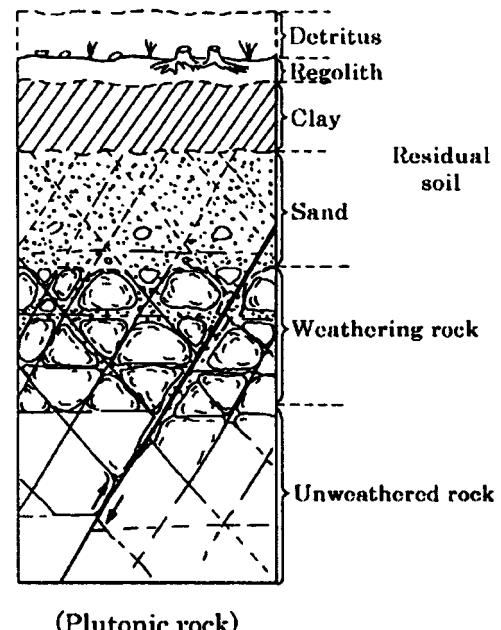
Fig. 7 Schematic representation of a weathering layer section.
(Deere and Patton 1971)

Bamboo grass has grown widely over the top of a failed slope in this region. The depth of the failed soil is about 0.5m -1m, and the surface soil at the failed slope is mostly homogeneous, decomposed granite where there is partially weathered rock. The surface of the failed slope is a sandy layer composed of weathered residual soil, as classified by Nishida (1986, 1991) and Deere and Patton (1971) (Fig.7). This is regarded to be the underlayer of the sandy

layer as there is partially weathered rock. Because the field survey was done by visual inspection and the hammer test, further examination is necessary to determine whether the failed surface classifies as a granite soil (zone IV, Masado B) or (zone V, Masado A) in the weathered soil classification of Kimiya (1975).

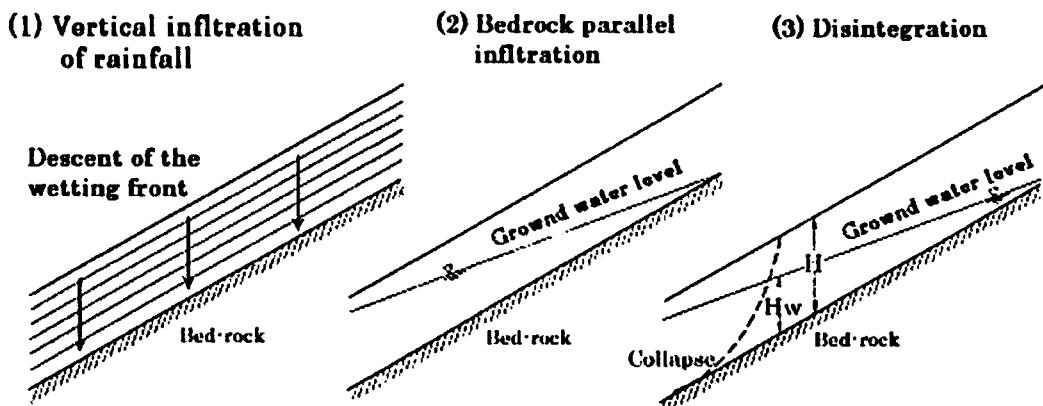
Fig. 8 The three slope failure mechanism stages. (Enoki 1999)

Geomorphological observation of the failed slope showed that it is convex, with a center top where the slope has a concave cross section. If slope failure is assumed to be limitless in weathered residual soil, the mechanism of failure caused by rainfall is explained by three stages (Enoki, 1999), as shown in Fig.8:

- 1) "Vertical infiltration of rainfall": Rainfall permeates the slope is surface soil, forming WF drops over time.
- 2) "Bedrock parallel infiltration process": The ground water table is in the surface soil layer after WF reaches the bedrock, and seepage flow parallel to the bedrock is generated.
- 3) "Collapse process" : Because this groundwater level is as high as downstream, it exceeds the limitation for the ground water level of some sites downstream, and this part collapses.

The slope in Neba Village seems to have failed by the above process.

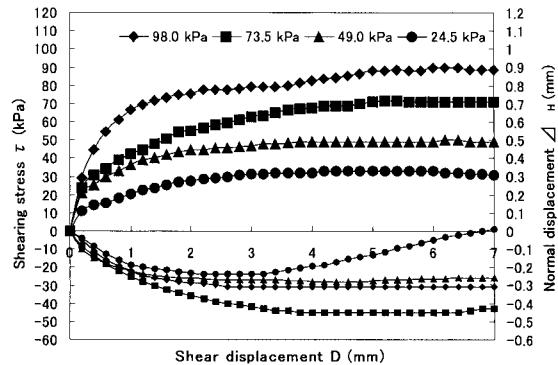
Fig. 9 Direct shear test (CD) results, Odona Neba Village

A direct shear test was made on the same sample. Test results for Odona in Neba Village are given in Fig.9, which it shows a relationship between the shearing stress τ , shearing displacement D and normal displacement Δ_n . In this test, the normal stresses applied were $\sigma_n = 24.5, 49.0, 73.5$ and 98.0 KPa. In this sample, displacement reached $D = 7$ mm, and the shear stress τ , increased linearly. The volume change characteristic during shear shows that the specimen increases in volume under the normal stress $\sigma_n = 24.5$ KPa, but decreases little at the other normal stresses.

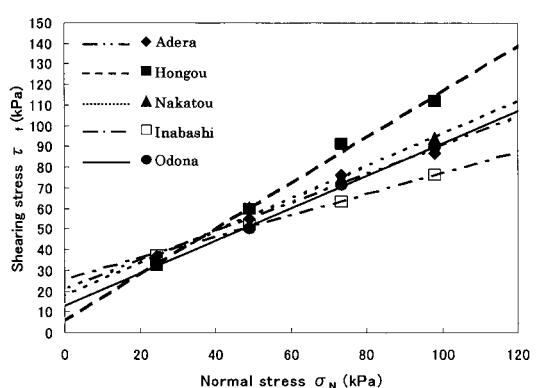
Fig. 10 Relationship between normal and shearing stress various sites.

Lines of rupture, including those of other landslide areas, are shown in Fig.10. Landslide areas where shearing tests were made, are beside Odora Neba Village, Adera and Hongo, Kamiyahagi Town, as well as Nakato and Inabashi, and Inabu Town. Strength coefficients, C_d and ϕ_d , as well as K_{15} , results of a constant-head

permeability test, (Fig.10) are given in Table 5. In this table, the adhesive strength becomes $C_d = 6.0\text{-}25.4\text{kPa}$, and internal friction angle $\phi_d = 27.5^{\circ}\text{-}47.9^{\circ}$. These findings give values closer to those of the soil whereas the strength constant of the general Masado gives someone higher/lower values in the report of Yamamoto, et al. (2001). These findings also seem to be affected by the mixing of humus soil and the difference in the degree of weathering of the Masado. The permeability test gave a permeability coefficient of $K_{15} = 2.1\text{-}10.1 \times 10^{-3}\text{cm/s}$.

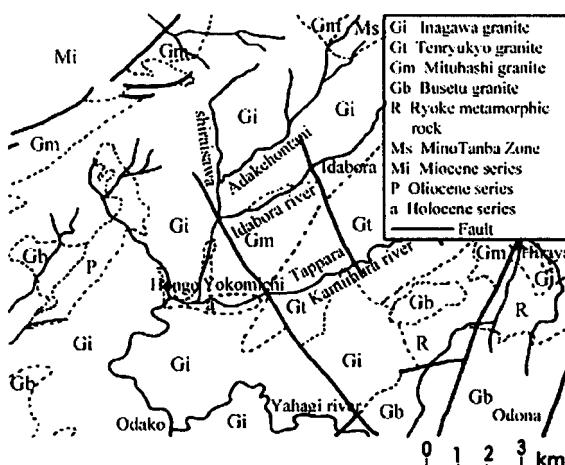
Fig. 11 Geological map of the Kamiyahagi Town area.

distributed in this area (Nakai, 1970). The area (Table 2, No.A3-A11) with rainfall more than 400mm in particular abounds in Tenryukyo granite. It has a steep landform in which the rock mass has been exposed, weathering erosion is slower than for the other granites, and the Masado of the surface layer is thinly extensible.

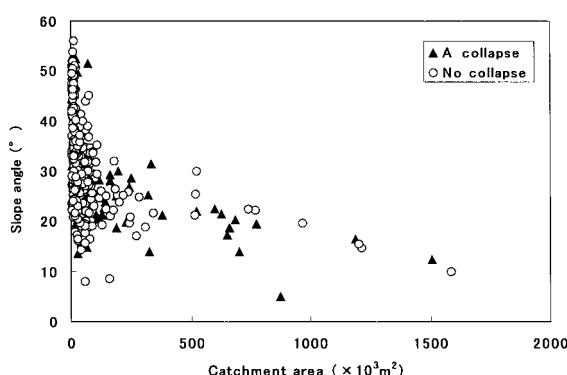
Fig. 12 Relationship between the catchment area and slope gradient of the failed slope.

Fig.12 shows the relationship between the slope gradient and catchment area of the catchment landform of the area near Kamiyahagi Town for the occurrence of landslides. The unfailed slope shown was chosen, because of the watersheds of both shores along several kilometers of the upper and lower stream between ridge and river, base on the mapping of 1/25000 and an aerial photograph. Although unfailed slopes are frequent even for steep slopes, there could be many failed slopes when the slope gradient is small and the catchment area large. We showed that the scale of the catchment area has a greater effects on slope failure than the size of the slope gradient. The failed slope area in Odona, Neba Village is shown in Fig.13. No wide catchment area can be seen in this area in Fig.12, the area being about $32 \times 10^3 m^2$ at maximum. The slope gradient is 20° - 55° , and the failed area also is within a similar landform condition.
